Phase I Environmental Site Assessment
Former Native Store Tank Farm
Grayling, Alaska

November 2012

1.0 INTRODUCTION

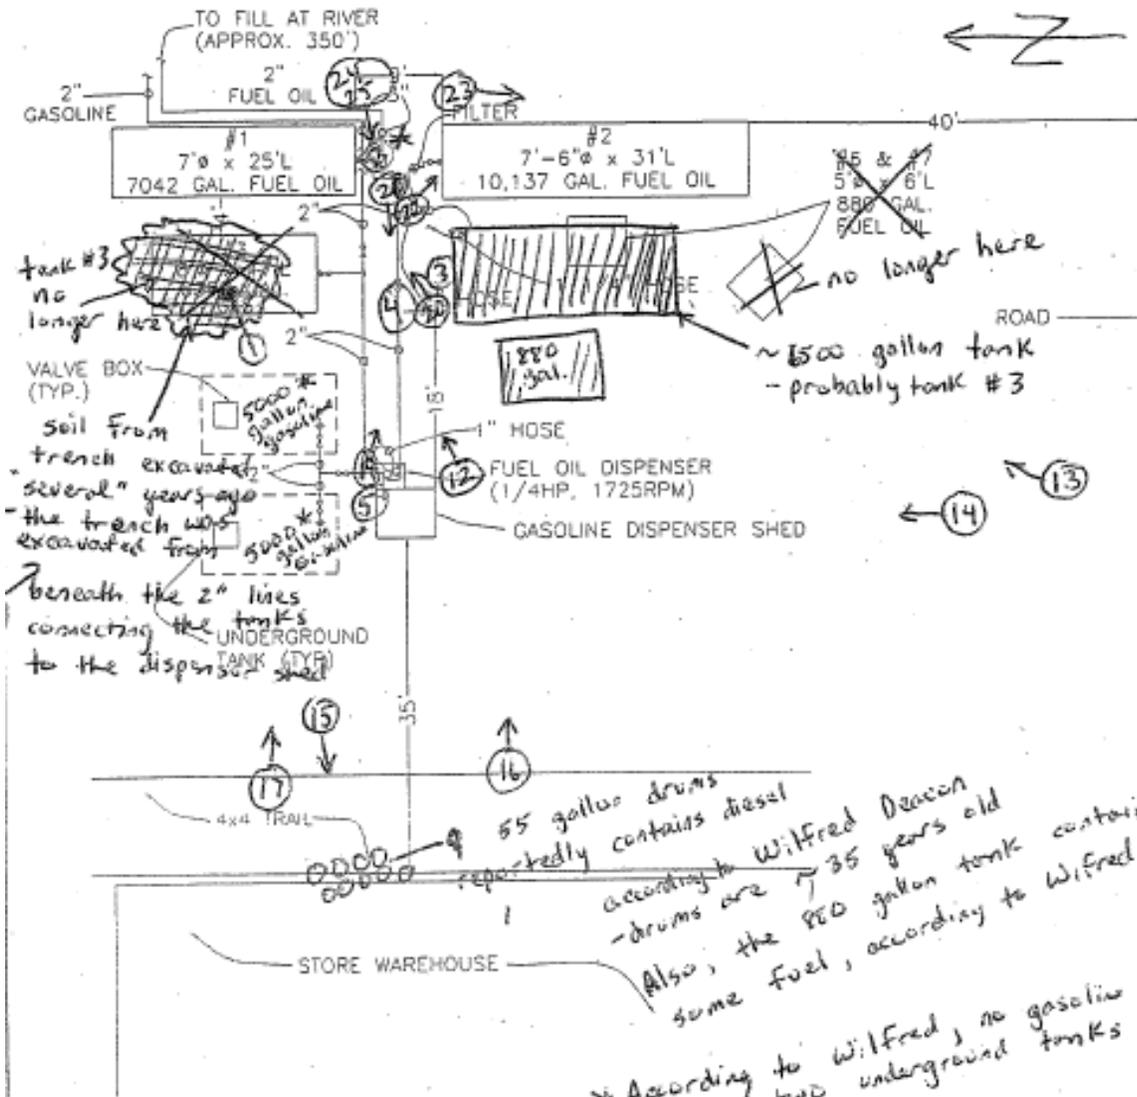
TANK FARM 3 GRAYLING NATIVE STORE

1. NO FENCE
2. NO SIGNAGE.
3. NO DIKE OR LINER
4. PIPE - TREADED STEEL, NO COATING, RUSTED (NUMEROUS JOINT LEAKS).
5. VALVES - BRASS CONSTRUCTION (2 VALVES W/ THREAD LEAKS)

55 gallon drums reportedly contains diesel according to Wilfred Deacon - drums are 35 years old

TANKS #1,2- HORIZONTAL, RIVETED STEEL, FAIR CONDITION. TANKS SET ON 2 COURSES OF HEAVY LOGS. MANHOLE & VENTS ON TOP.

TANKS #4,5- UNDERGROUND TANKS, STEEL CONSTRUCTION, CONDITION UNKNOWN. VENTS IN VALVE BOXES ARE CAPPED.

TANKS #3,6 & 7- HORIZONTAL, WELDED STEEL, FAIR CONDITION. TANK #3 & 6 ON GRADE, TANK #5 ON 2 COURSES HEAVY LOGS. TANKS USED BY AIRPORT CONSTRUCTION COMPANY.

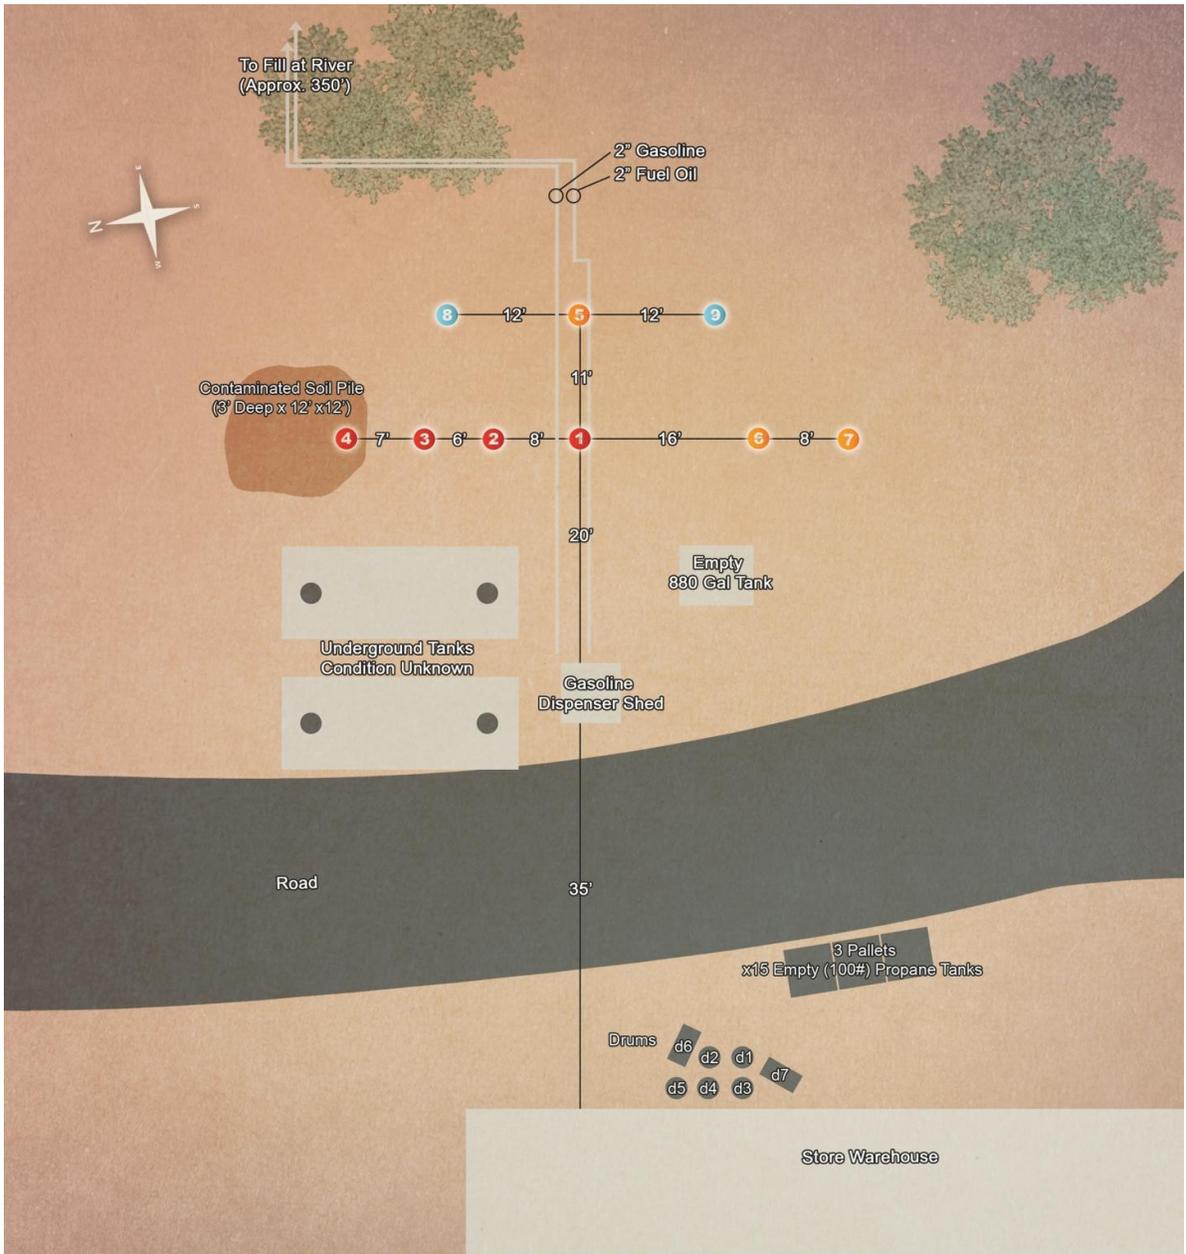
Grayling Native Store & Tank Farm
 Grayling, AK
 10/24/12

Shallow soils were screened for contamination and one contaminated area identified adjacent the stockpile that measured about 20 X 10 X 4 feet or greater and roughly estimated at 30 yds³. The sandy soil was compliant until 4 to 4.5 feet at dense gravel. Screening was performed at the middle of each hole where contamination was strongest.

Seven drums remain on the property of nine documented in 2000. These are numbered in Exhibit 6. Drums 1-3 were checked with drum thieves and found to be full of petroleum contaminated water with minimal free product. Drums 4-6 could not be opened using a steel bung wrench do to rust and the degraded condition of the drums. Further investigation was not performed on these drums because we did not have capacity to respond to release or to properly contain the drums if we couldn't get them closed. Drum 7 contained about 45 gallons of unused heavy weight oil and was on its side leaking from its missing bung. Nathan Elswick found a replacement bung and installed it. Previous investigators were informed the 9 drums present if 1998 contained waste diesel. Therefore, drums 4-6 are suspected to contain diesel. None of these drums are in satisfactory condition and each presents a potential spill source.

Once tanks are registered it is recommended they be decommissioned following the UST Procedure Manual requirements. Phase II Characterization of contaminated soil and stockpile should include laboratory sampling following an ADEC approved workplan to define the level of contamination. Upon completion of characterization a Conceptual Site Model should be developed for ADEC use in determining cleanup levels that will apply to the site. Informed by the level of contamination and cleanup level a Phase 3 site cleanup can be planned in coordination with ADEC to resolve human exposure concerns and close the site. Depending on the level of contamination that remains after cleanup ADEC may require institutional controls to limit uses of the property and minimize human exposure.

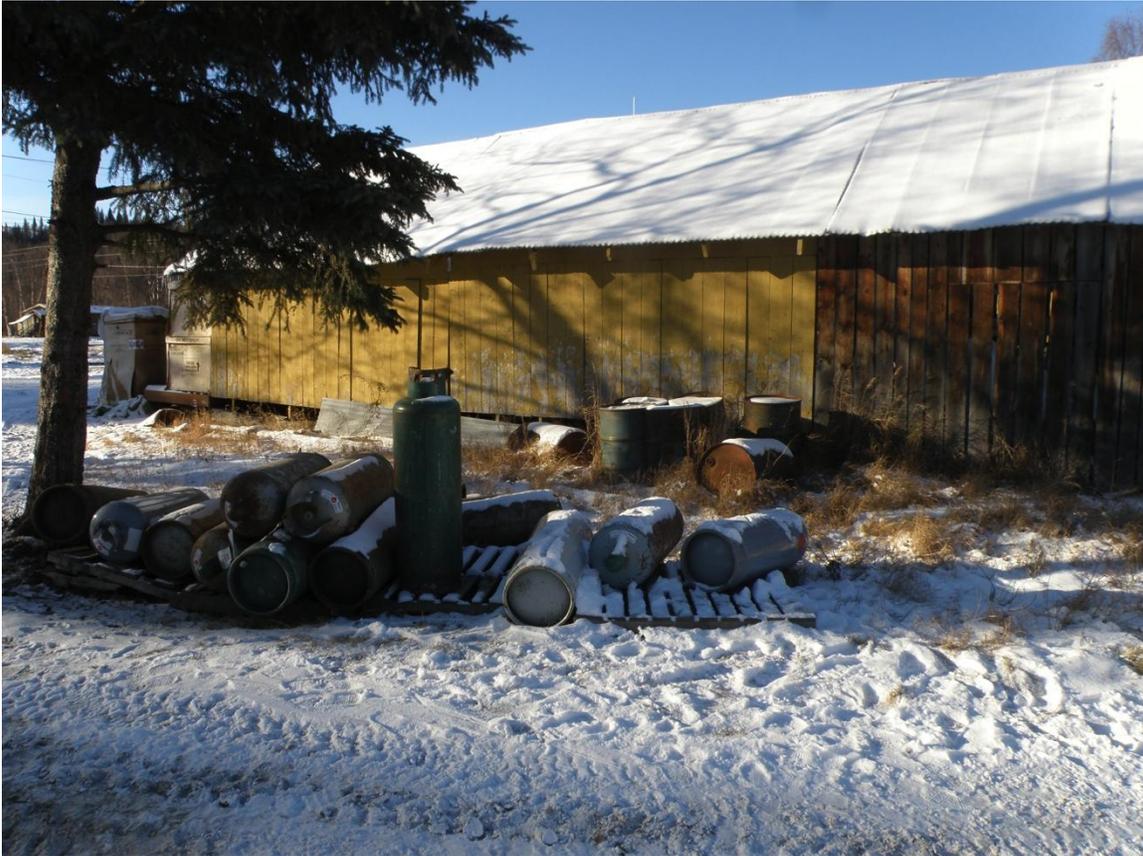
Photo 2: Propane tank storage area in foreground with seven drums behind

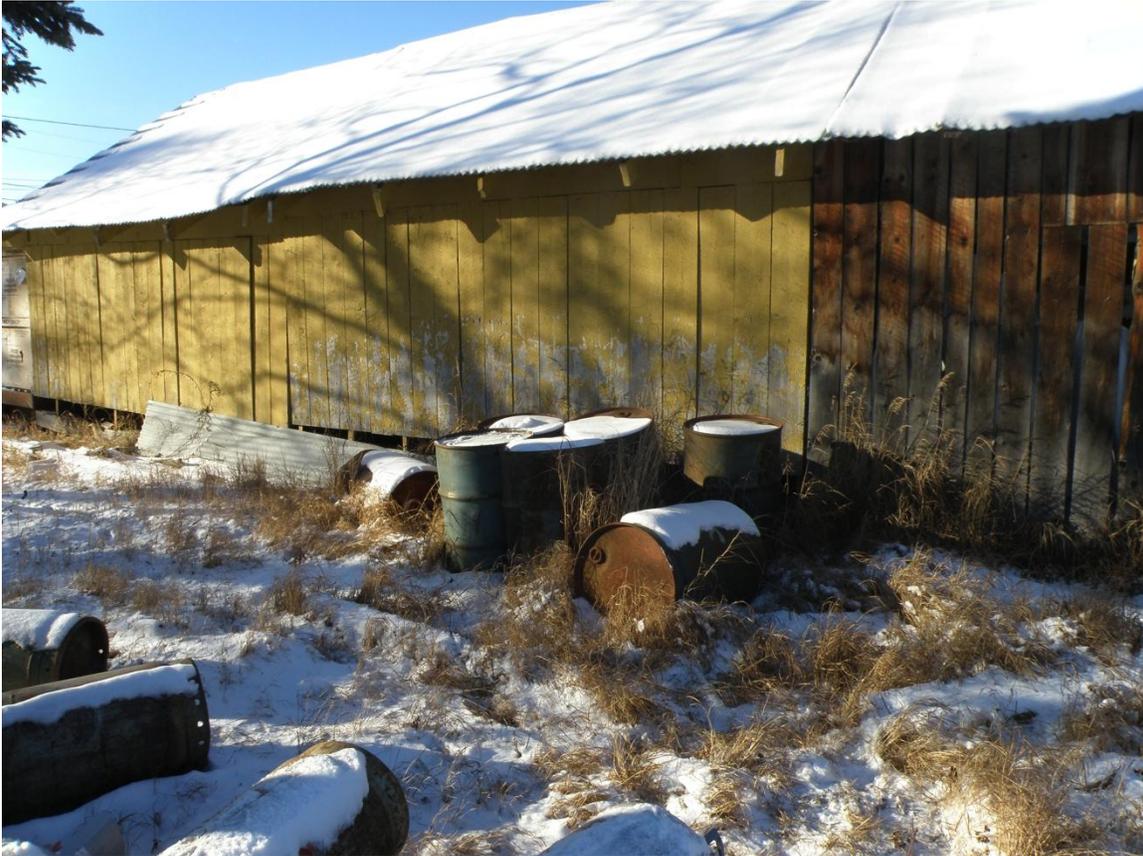
Photo 3: Seven drums remaining on subject property

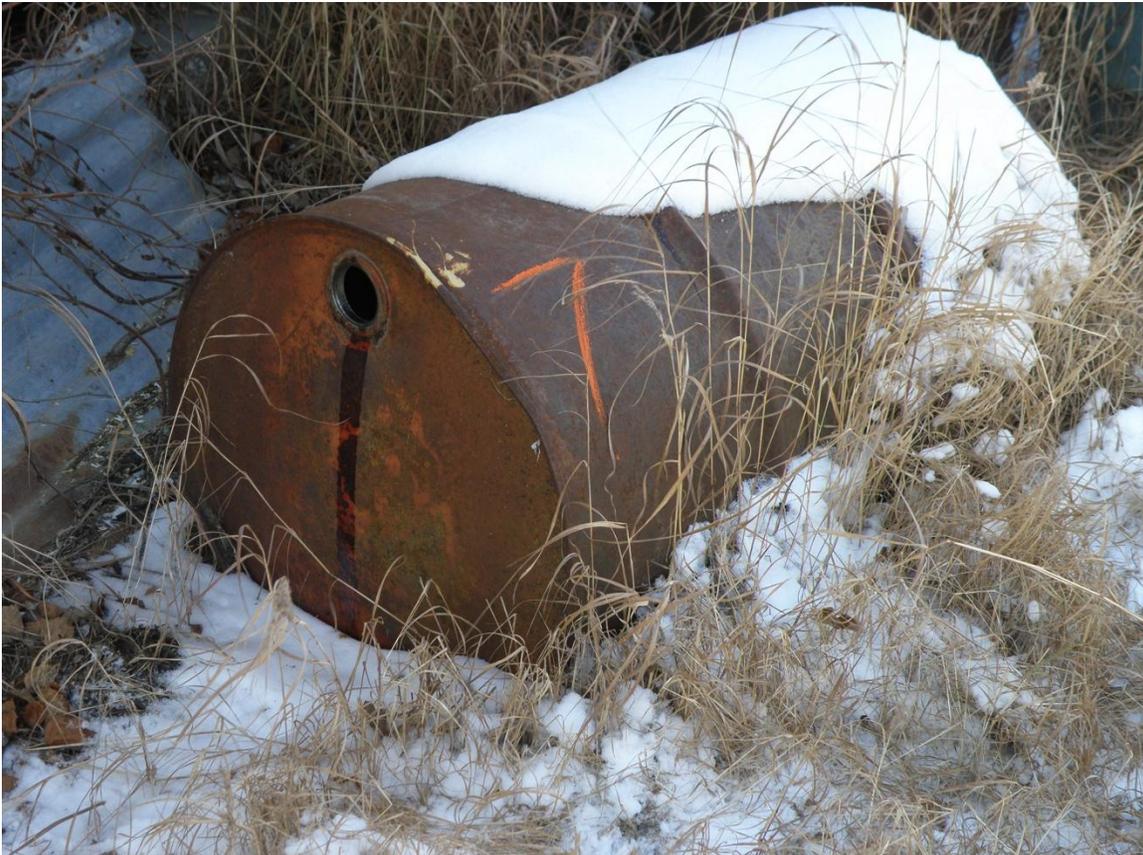
Photo 4: Drum found leaking. Identified as drum 7 in Exhibit 6

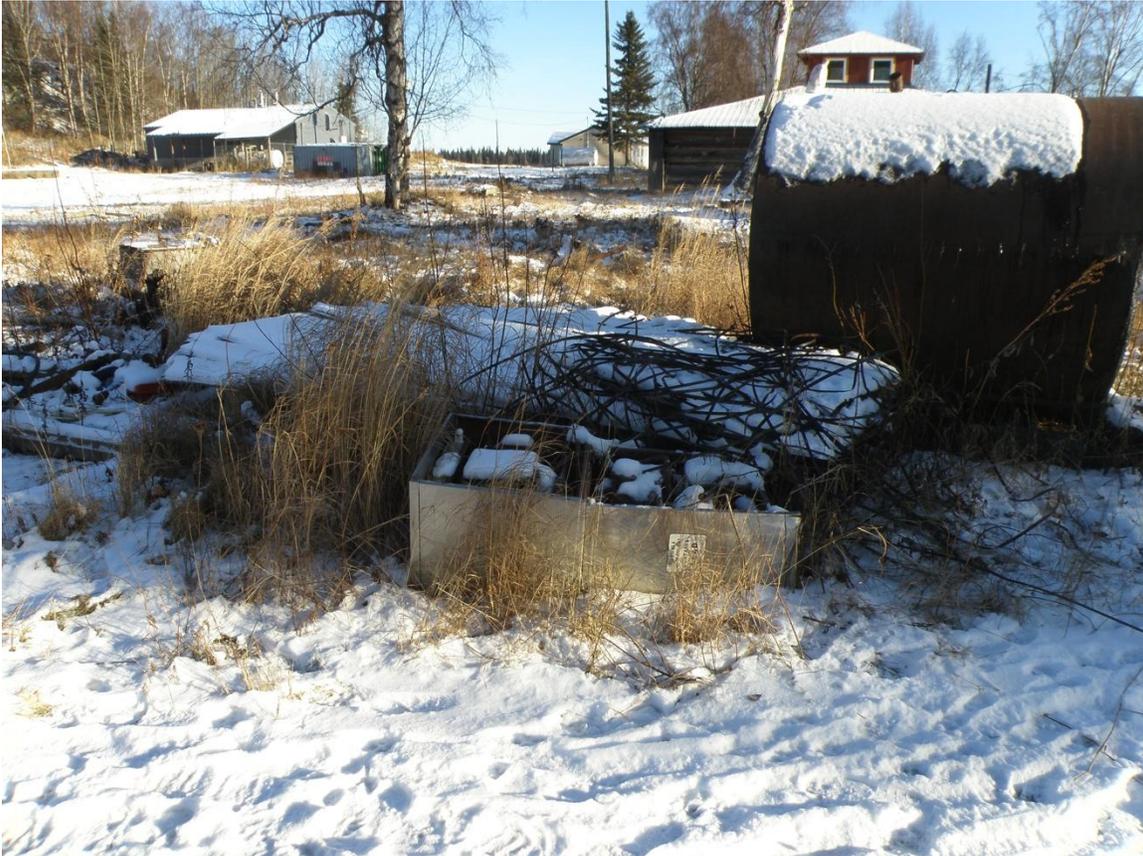
Photo 6: Empty 880-gallon aboveground tank remains on subject property

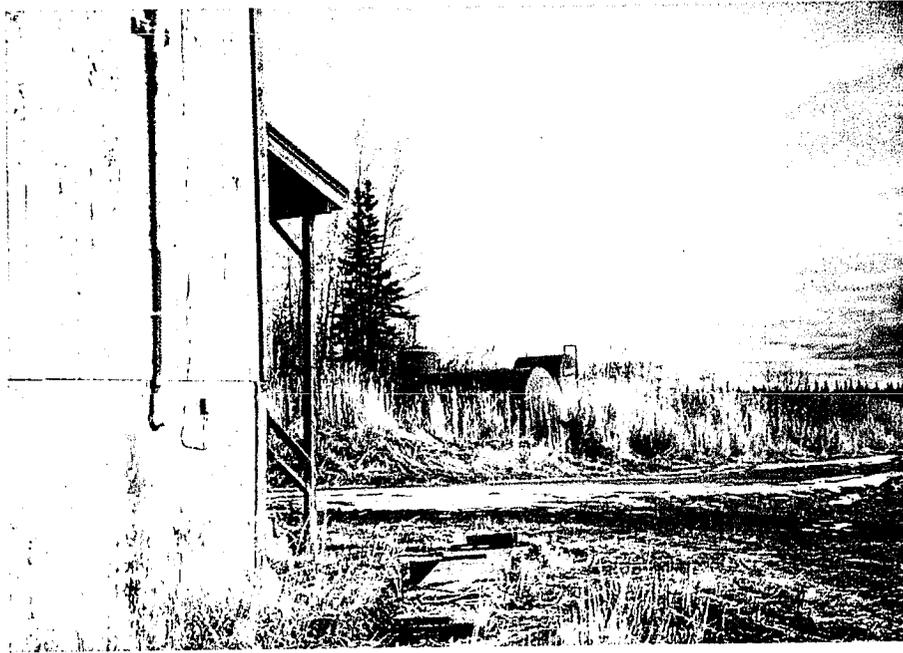
Photo 1: Tank Farm 1; This photo was taken from next to the school mechanical building. The railroad car and the red 800-gallon AST are the only tanks currently located at this tank farm.

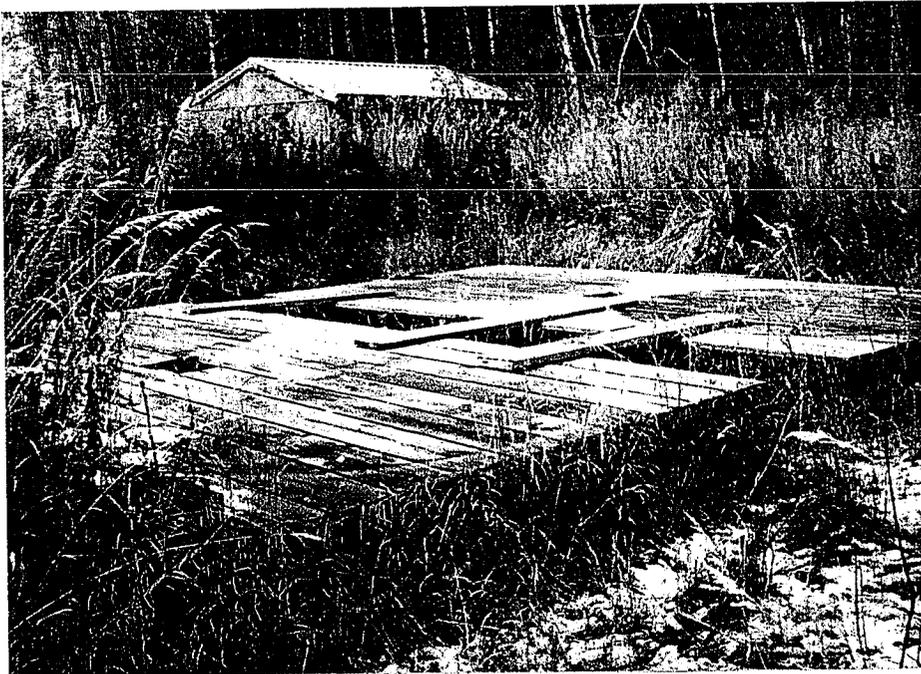
Photo 2: Tank Farm 1; The four vertical tanks used at this tank farm were situated on the wood platforms shown above. Slight staining is visible on the wood.

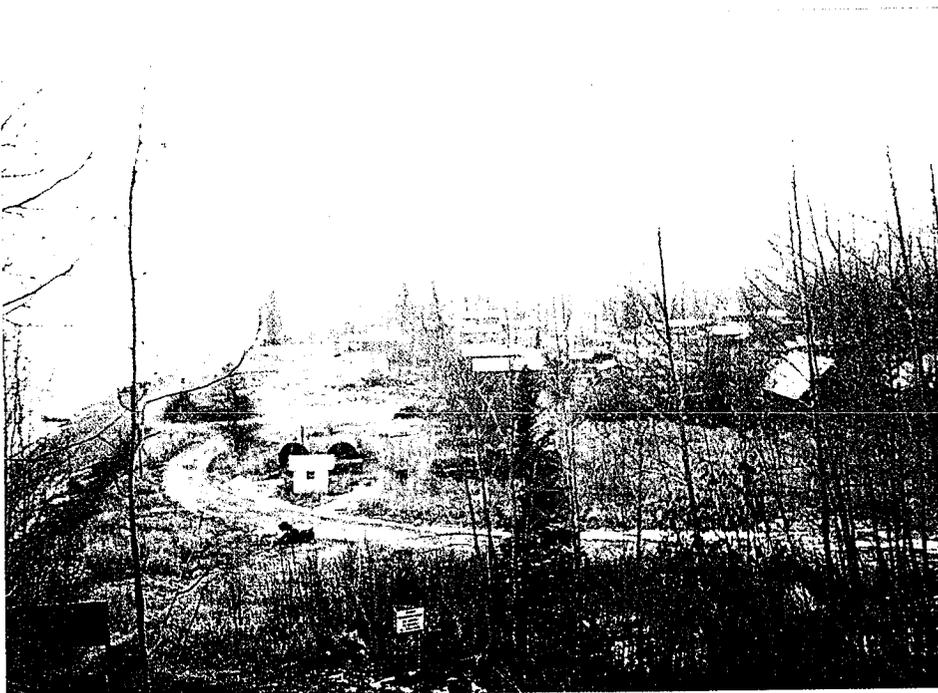
Photo 3: Tank Farm 2; Tank Farm 2 is located next to the white shed on the left. Tank farm 2 is comprised of the two red tanks behind the shed and the black railroad car tank to the right. Tank Farm 1 is partially visible at the bottom of this picture.

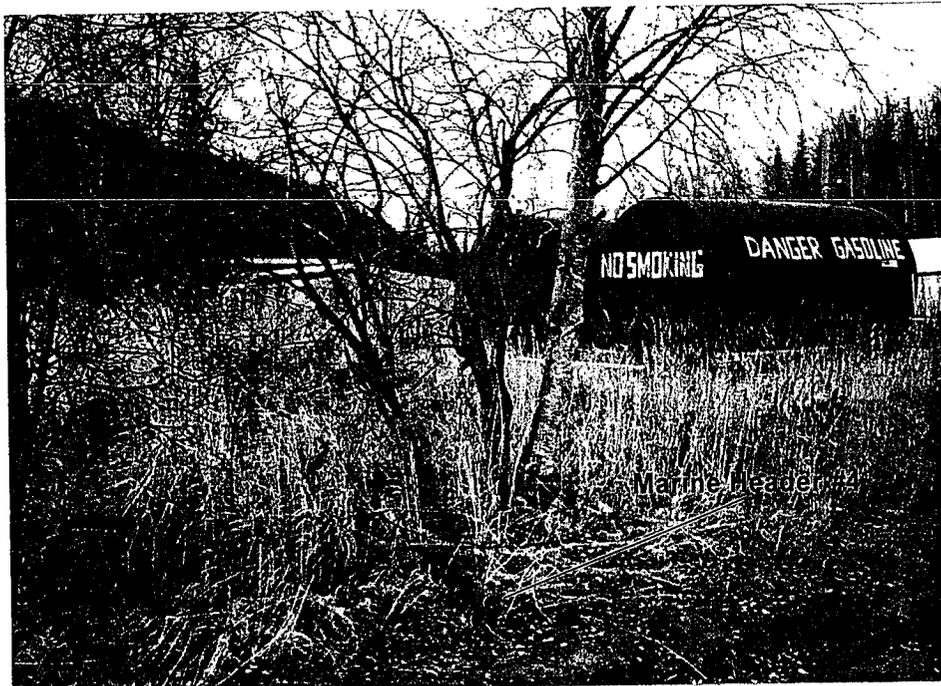
Photo 4: Tank Farm 2; The bungs have been removed from the tops of these tanks, and they may contain water. Both tanks are rusted and in poor condition.

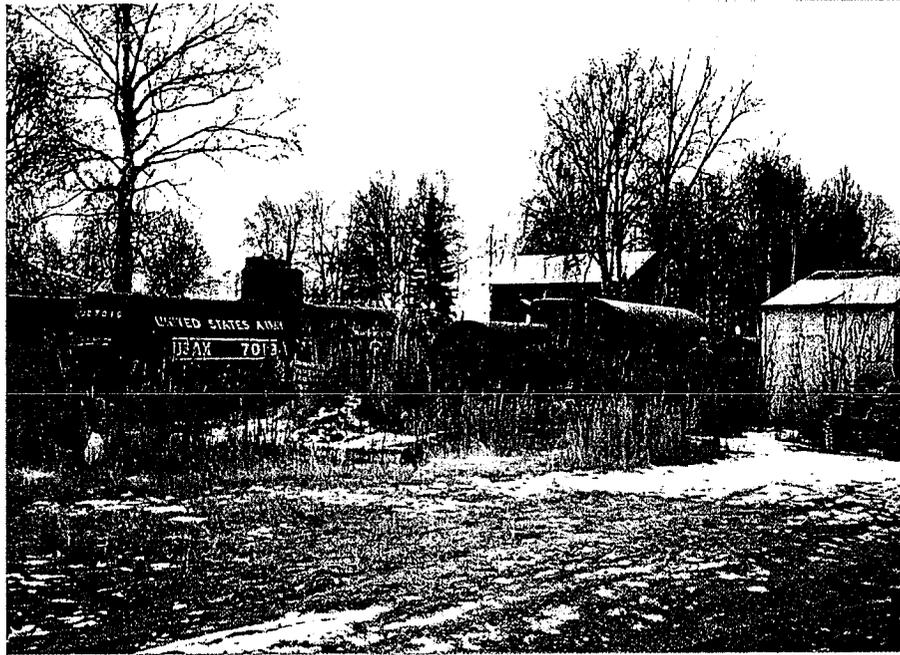
Photo 5: Tank Farm 3; The tanks shown comprise Tank Farm 3. The small tank closest to the white shed reportedly still contains fuel. The other tanks at this tank farm are reportedly empty. A small soil stockpile is visible to the left.

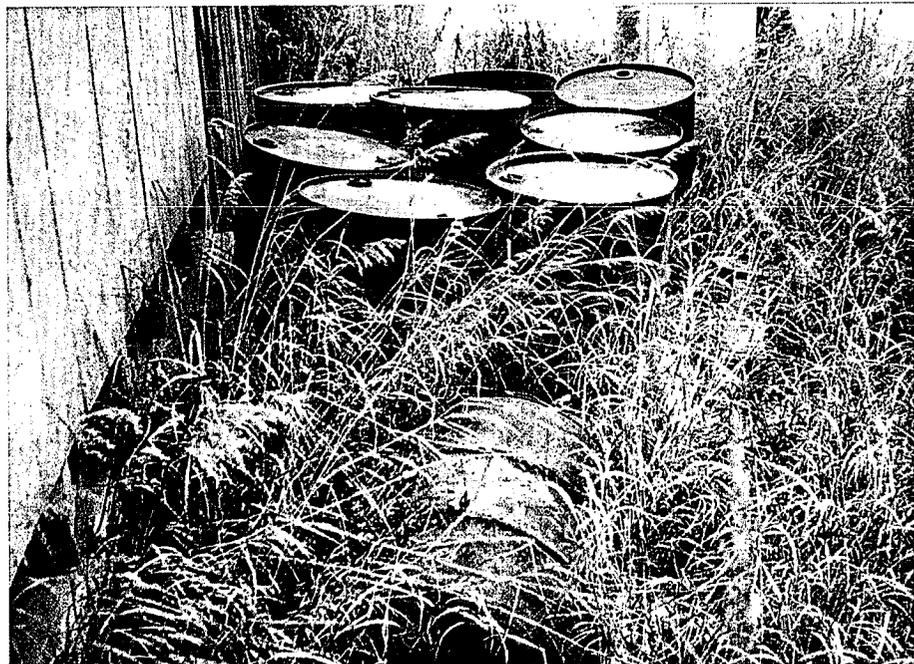
Photo 6: Tank Farm 3; These nine drums are situated against the east side of the Grayling Native Store, which is approximately 40 feet to the right of the tanks shown above.

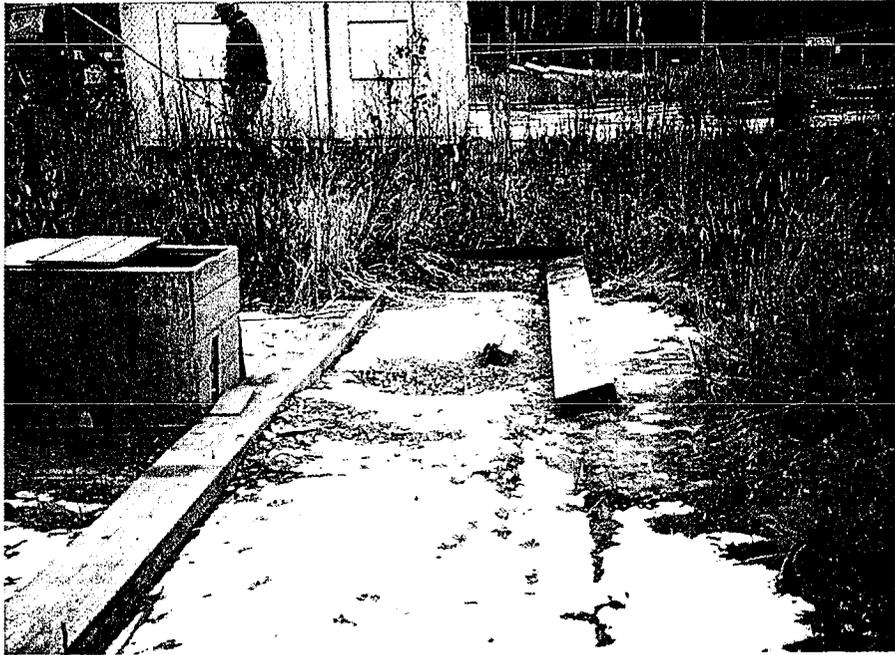
Photo 7: Tank Farm 4; The tanks from this tank farm have been moved to Tank Farm 6. The wood timbers that supported the tanks are shown above. The unlined gravel dike that encompassed the tanks is partially visible.

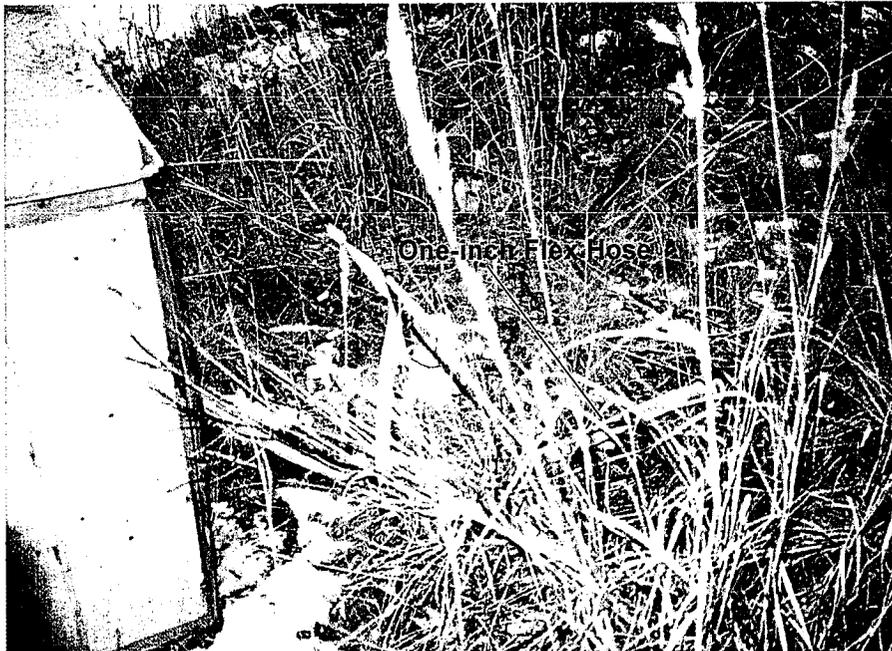
Photo 8: Tank Farm 4; The red one-inch flex hose indicated above is connected to a buried steel pipe that runs to the city building.

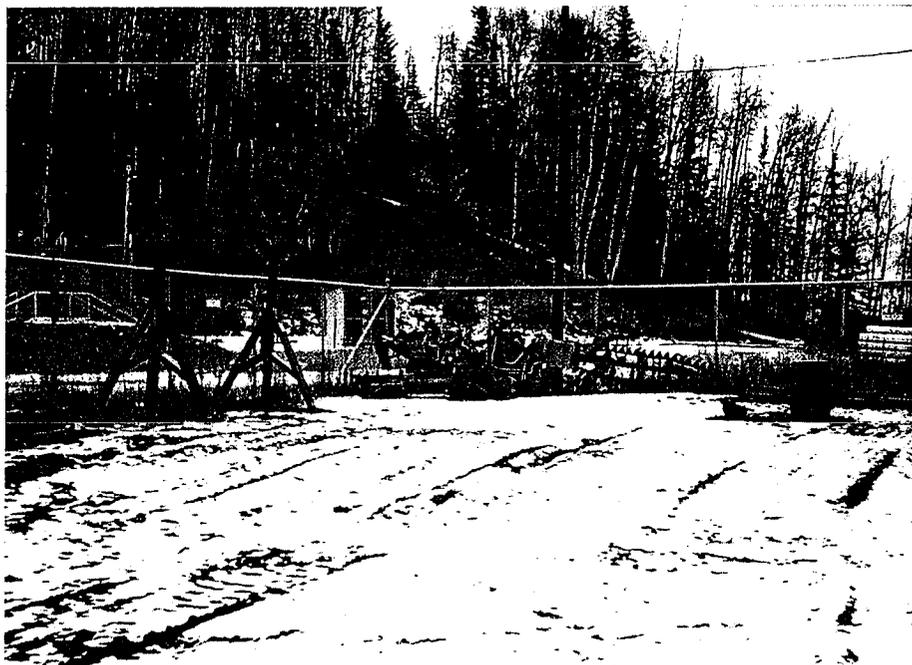
Photo 9: Tank Farm 5; The tanks from this tank farm have been moved to Tank Farm 6. The open area shown above is where the eight AVEC tanks were formerly located. The original pad has been covered with the gravel that comprised the former tank farm dike.

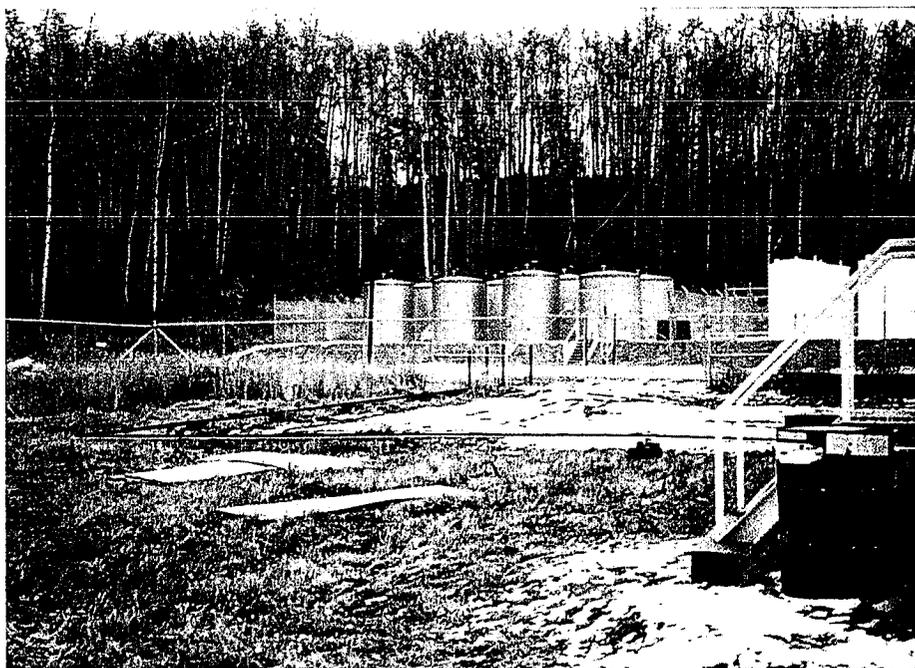
Photo 10: Tank Farm 5; The fuel line shown above runs from the AVEC tanks located at Tank Farm 6 (shown in the background) to the AVEC powerhouse.

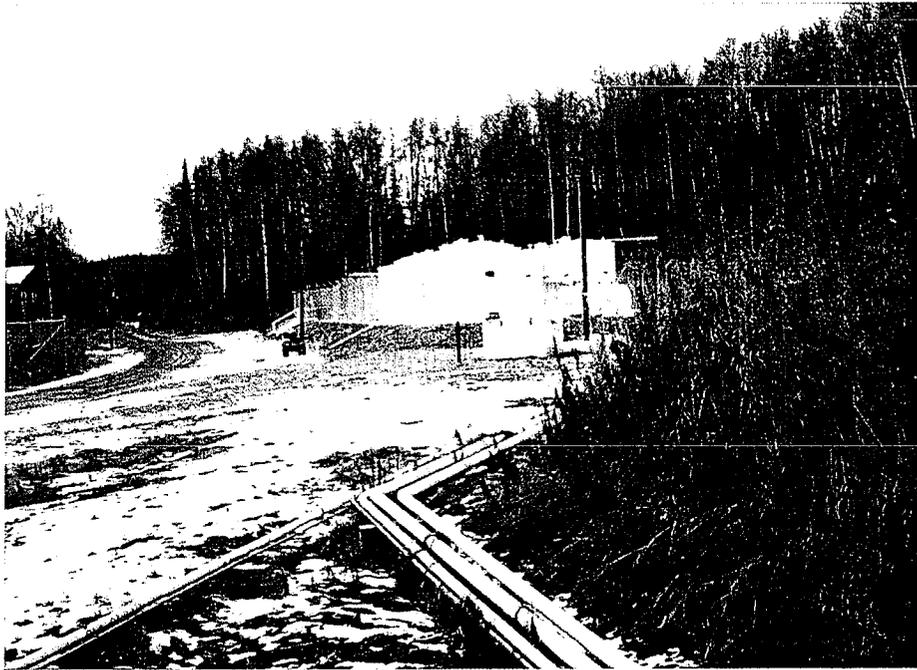
Photo 11: Tank Farm 6; Header #1 and the fuel line to Tank Farm 7 are shown in the foreground to the right. The single pipe branching to the left serves the city building and the water treatment plant. Tank Farm 6 is encompassed by a locked fence. A dispenser for local fuel consumption is located in the white shed shown above.

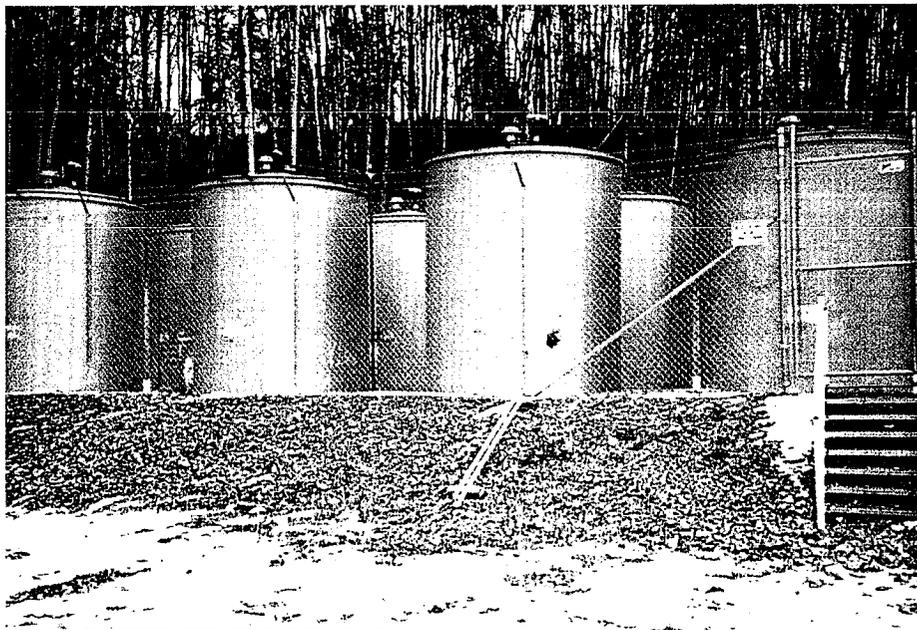
Photo 12: Tank Farm 6; The tanks shown are owned by AVEC and are located within their own dike. These tanks are separated from the rest of Tank Farm 6 by an internal fence and have a separate entrance gate, which is shown to the right.

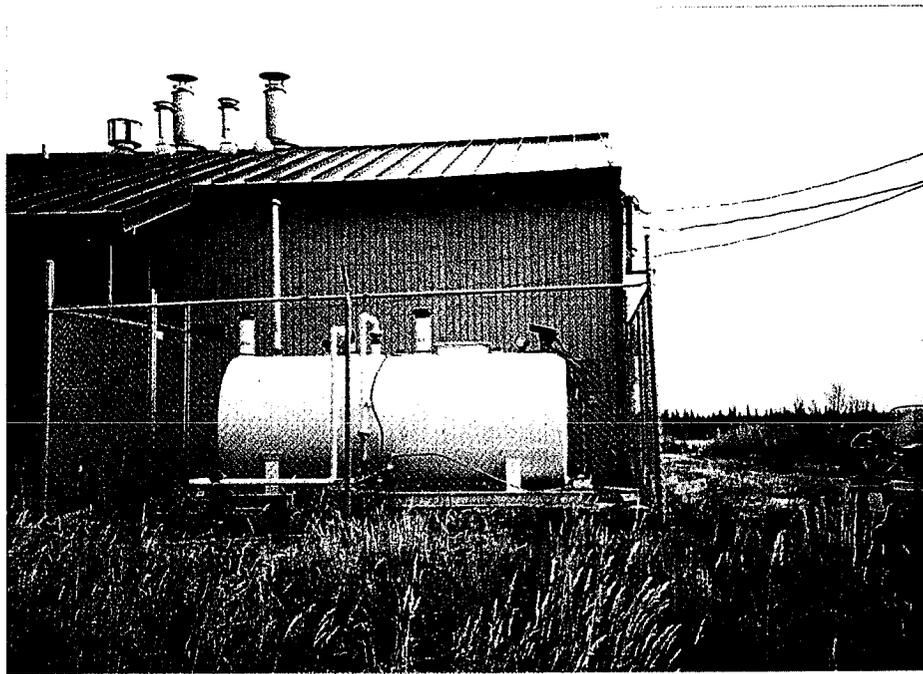
Photo 13: Tank Farm 7; The school mechanical building is shown directly behind the tank. This tank is filled from Tank Farm 6 via a 2-inch steel pipe.

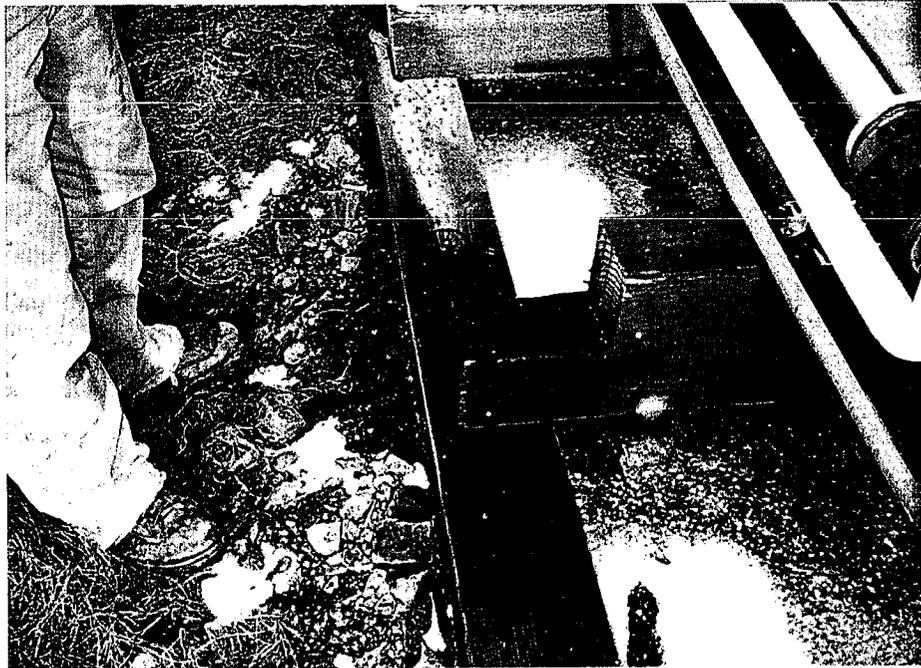
Photo 14: Tank Farm 7; Staining is visible on the timber comprising one side of the containment dike. This tank is supported by timbers spanning the dike. This tank farm was fenced but not locked.

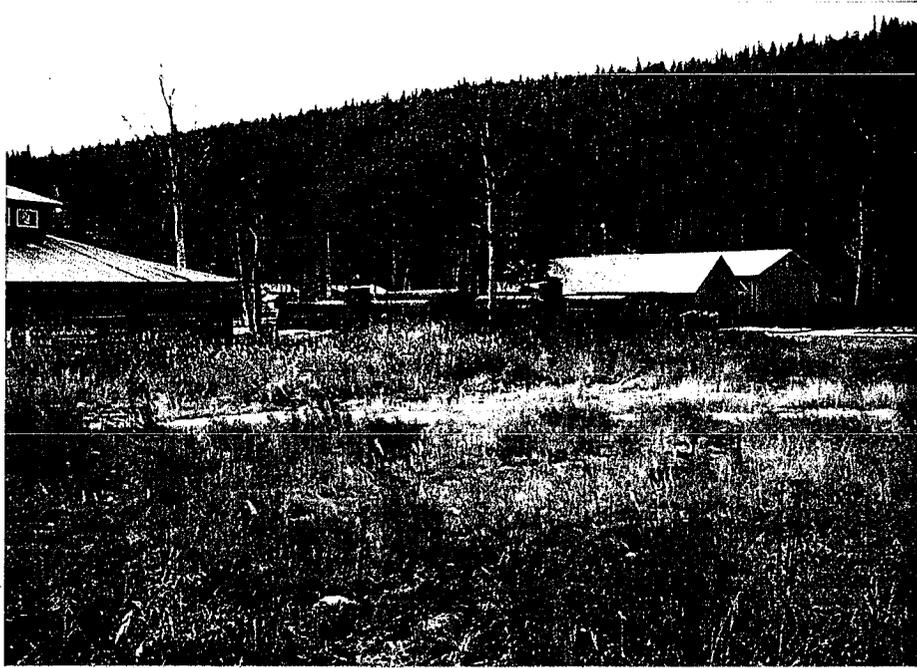
Photo 15: Tank Farm 8; The grassy area shown above is the reported location of Tank Farm 8. Tank Farm 3 is visible in the background.

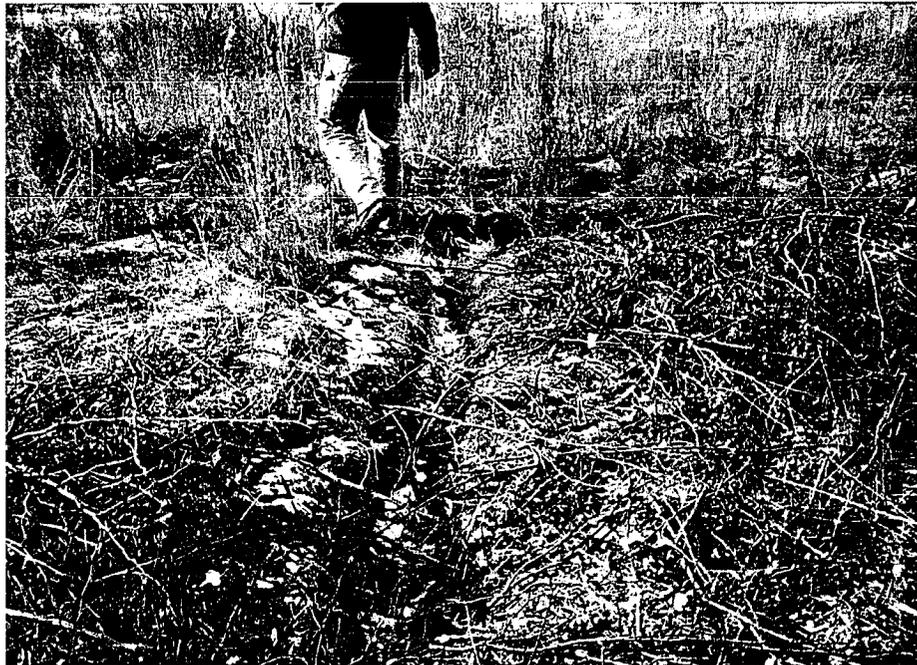
Photo 16: Tank Farm 8; The trench shown above is believed to be the former location of Header #3.

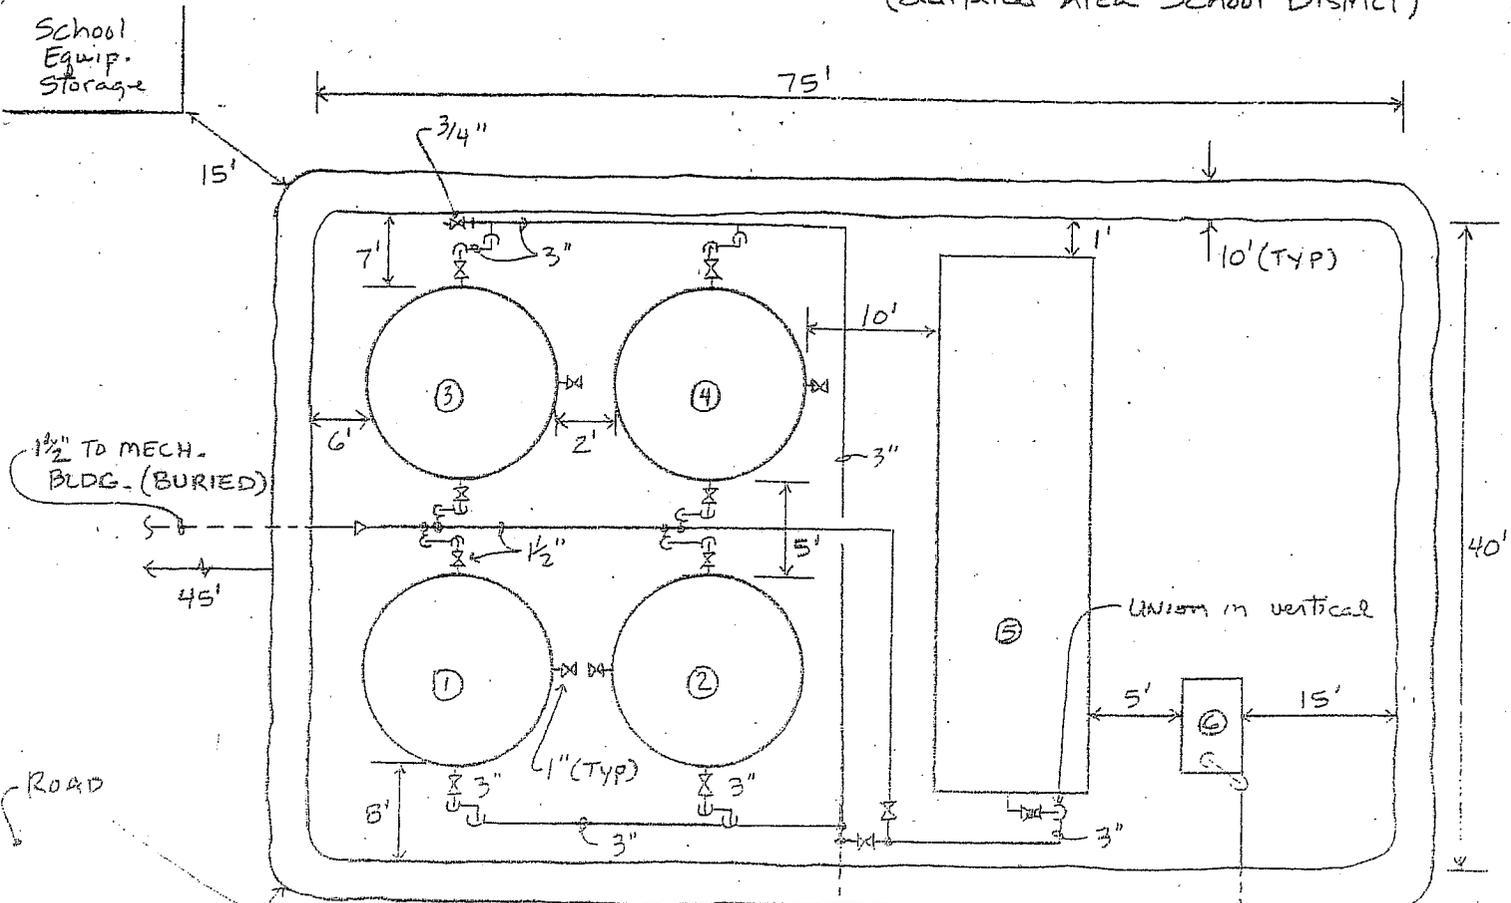
Tank Farm #1, Old School tank Farm, 10/18/00 Wednesday
 Photos → Grayling School Area"

1. No fence
2. Dike of gravel & dirt w/ liner, 3' high with standing water inside dike. Many weeds.
3. 3" pipe - steel w/ grooved fittings, NO coatings, rusted (Thread leaks 3 Total)
4. 1 1/2" pipe - threaded & grooved steel, partially painted
5. Valves - brass construction. Each tank has a GV w/ value packing leak

TANKS #1,2,3,4 : BIA type, vertical, steel, welded, w/ removable top. Tanks in fair condition w/ some minor rust where paint has peeled. A wood foundation is used w/ 4 courses (2x12 on 4x12 on 2x12 on 2x12). Each tank w/ MH & vents on top. A 3" & 1 1/2" brass GV is a each of the tanks; virtually every valve packing is leaking.

Tank #1,3 9'φ x 14'H 6420g. Fuel Oil Tank #2,4 8'6"φ x 14'H 5730g. Fuel O

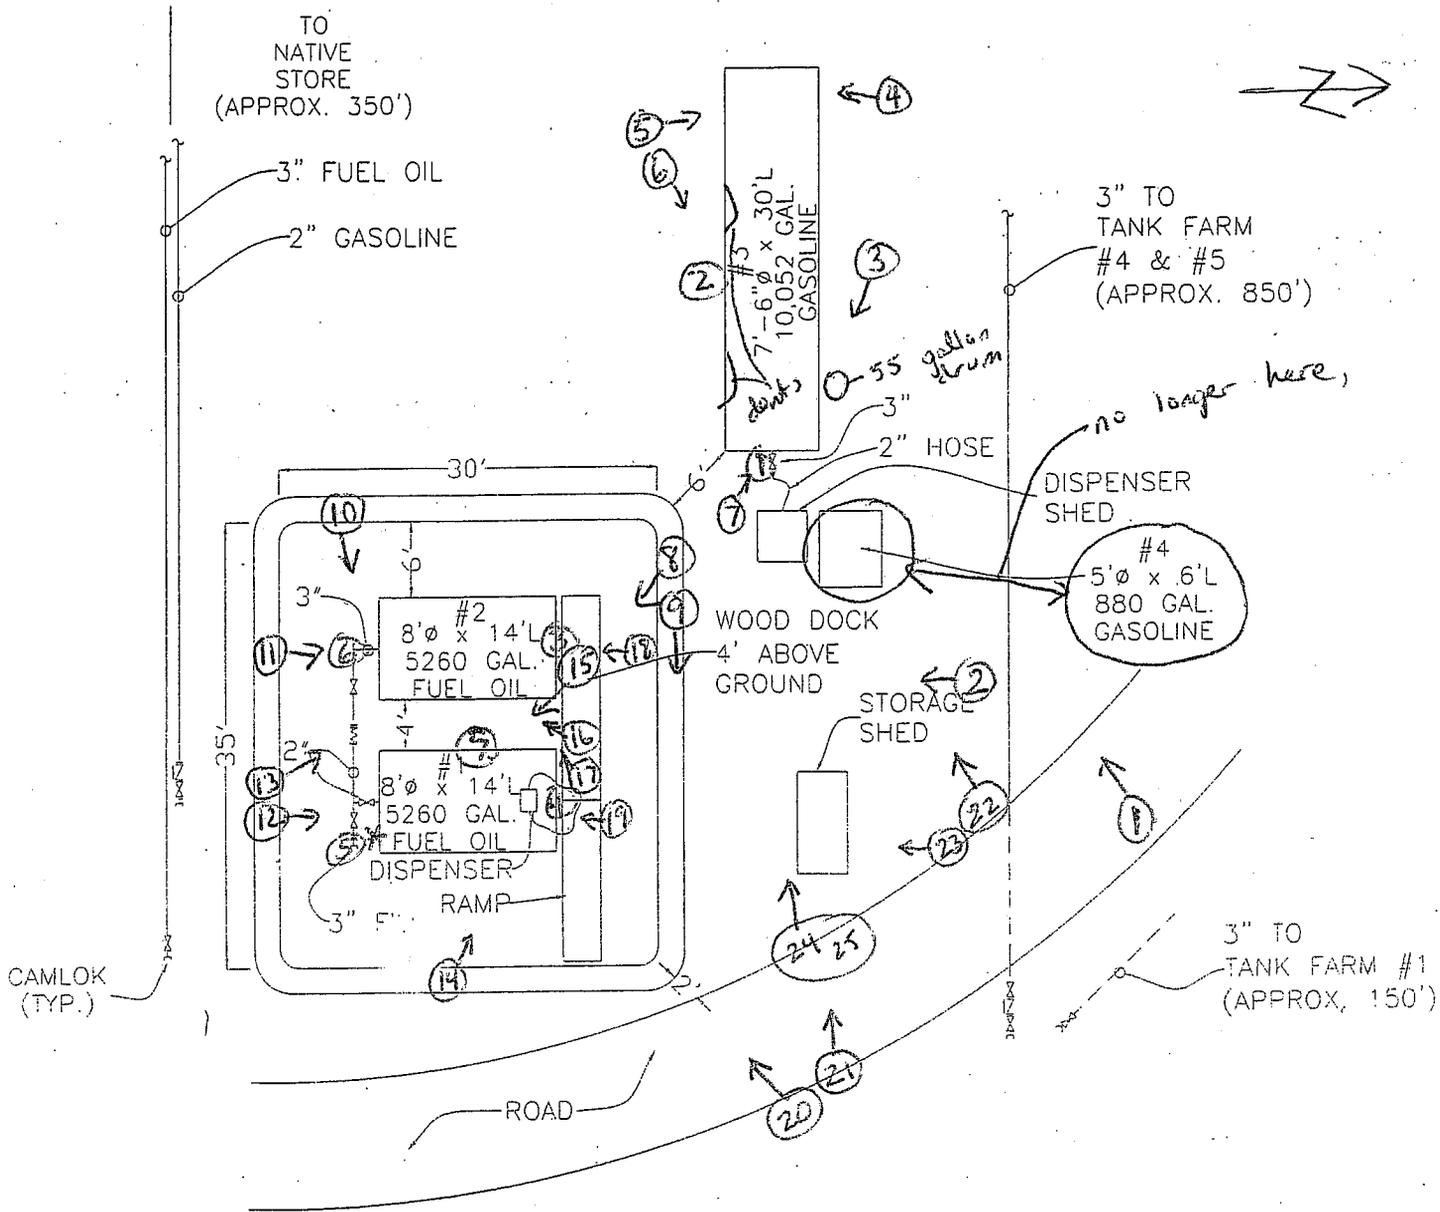
1. NO FENCE
2. SIGNAGE POSTED FOR WARNING.
3. GRAVEL DIKE 1' HIGH WITH BREAKS IN DIKE SUCH THAT NO CONTAINMENT. NO LINER.
4. TANK FARM FOR RETAIL SALES.
5. PIPE THREADED GALV. STEEL (3 LEAKS NOTICED - VALVES THREADED, HOSE BAND CLAMPS).
6. DIKE ONLY AROUND TANKS #1 & 2.
7. VALVES BRASS CONSTRUCTION.
- 8: EXPOSED ROMEX WIRE (HOT) TO TANKS FOR PUMPS.
