Phase I Environmental Site Assessment
Former Native Store Tank Farm
Grayling, Alaska

November 2012

1.0 INTRODUCTION

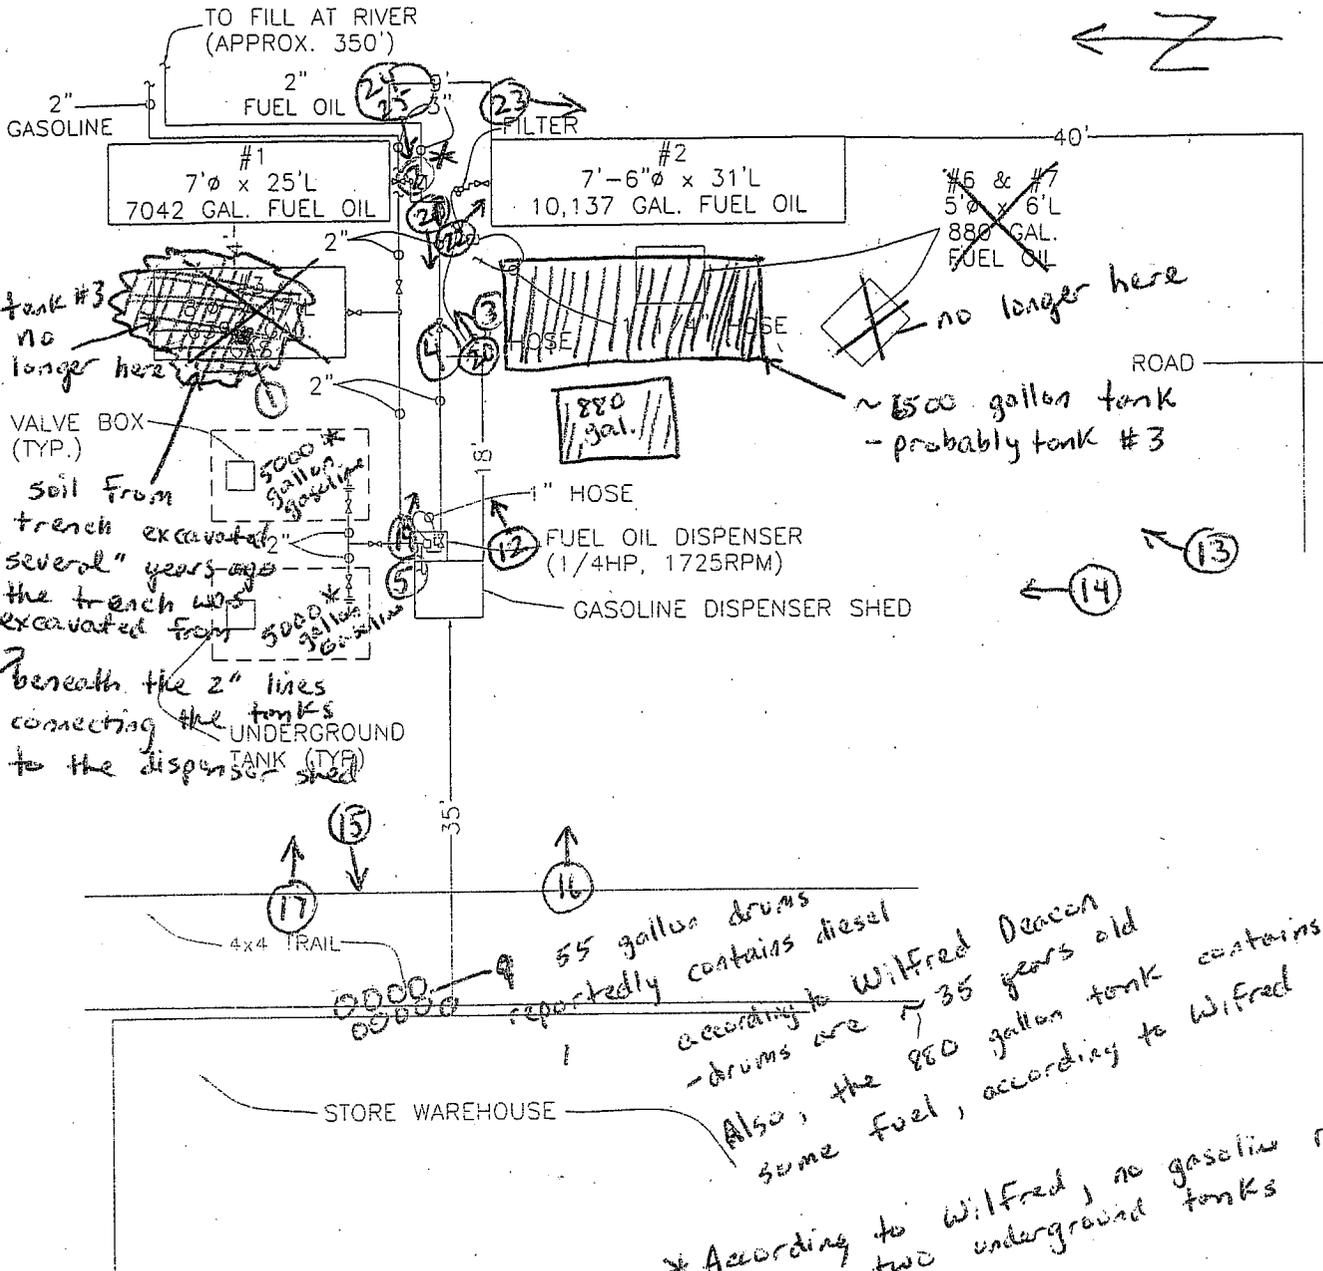
TANK FARM 3 GRAYLING NATIVE STORE

1. NO FENCE
2. NO SIGNAGE.
3. NO DIKE OR LINER
4. PIPE- TREADED STEEL, NO COATING, RUSTED (NUMEROUS JOINT LEAKS).
5. VALVES- BRASS CONSTRUCTION (2 VALVES W/ THREAD LEAKS)

TANKS #1,2- HORIZONTAL, RIVETED STEEL, FAIR CONDITION. TANKS SET ON 2 COURSES OF HEAVY LOGS. MANHOLE & VENTS ON TOP.

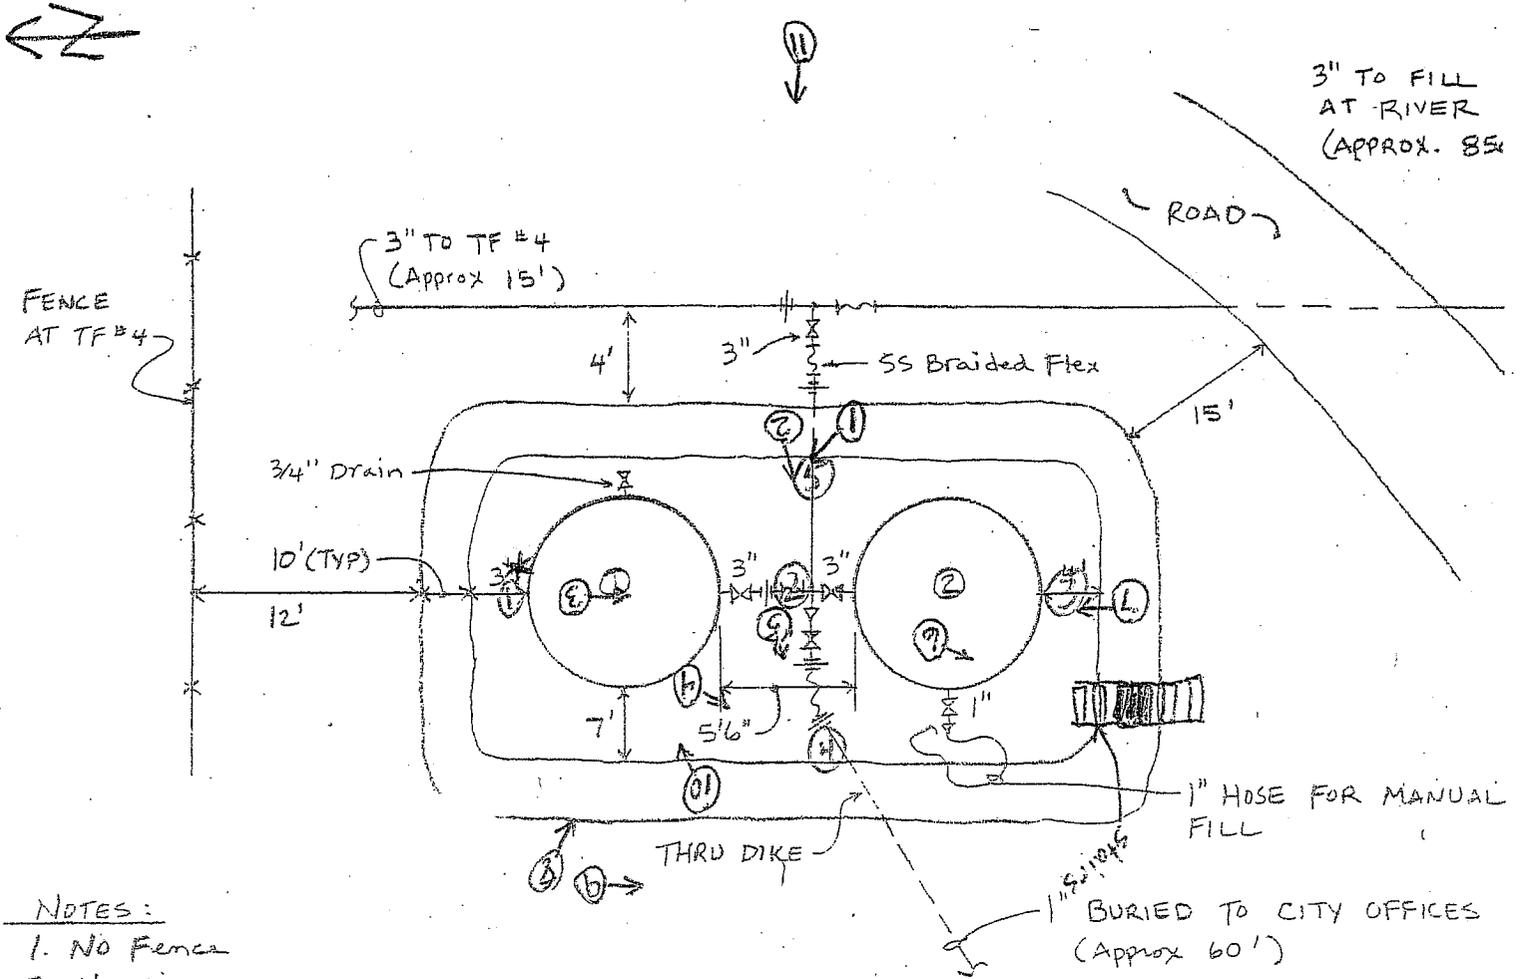
Grayling TF #4 City of Grayling

* 10/19/00 - tanks have been moved to the new tank farm

1. No Fence
2. No signage
3. Dike - 1' HIGH gravel dike without liner
4. Pipe - threaded steel, painted w/ some rust. Leaks @ threads & unions (4 TOTAL)
5. Valves - Brass construction. One valve w/ packing leak
6. TF serves city offices & washeteria.

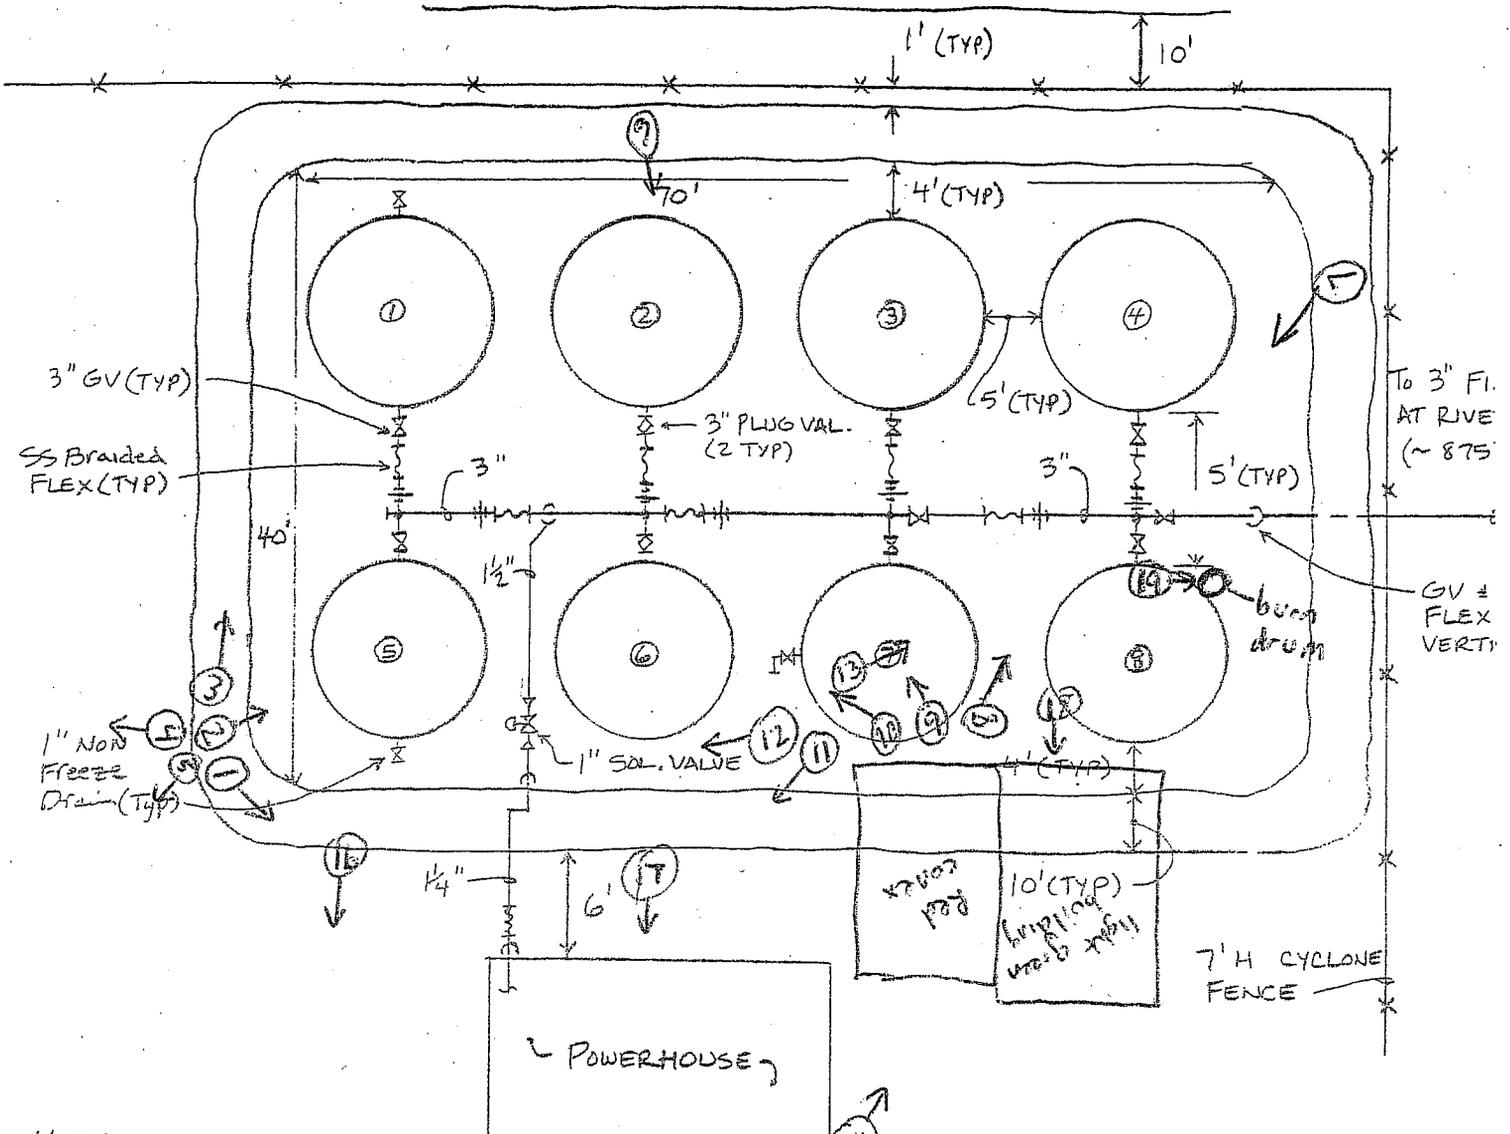
Tank Farm #5, AVEC POWERHOUSE, 10/19/00, Thursday, GRAYLING

1. NO signage
2. Fence around entire facility, Not complete but still under construction
3. Pipe - threaded steel, painted. Thread leaks apparent (4 total). [Fill pipe w/p Vic & thread]
4. Valves - GV brass construction. One valve w/ packing leak
Plug Valves - steel construction
5. 3'H gravel dike with no liner. Liner under tanks #1,5 only
No dike drain

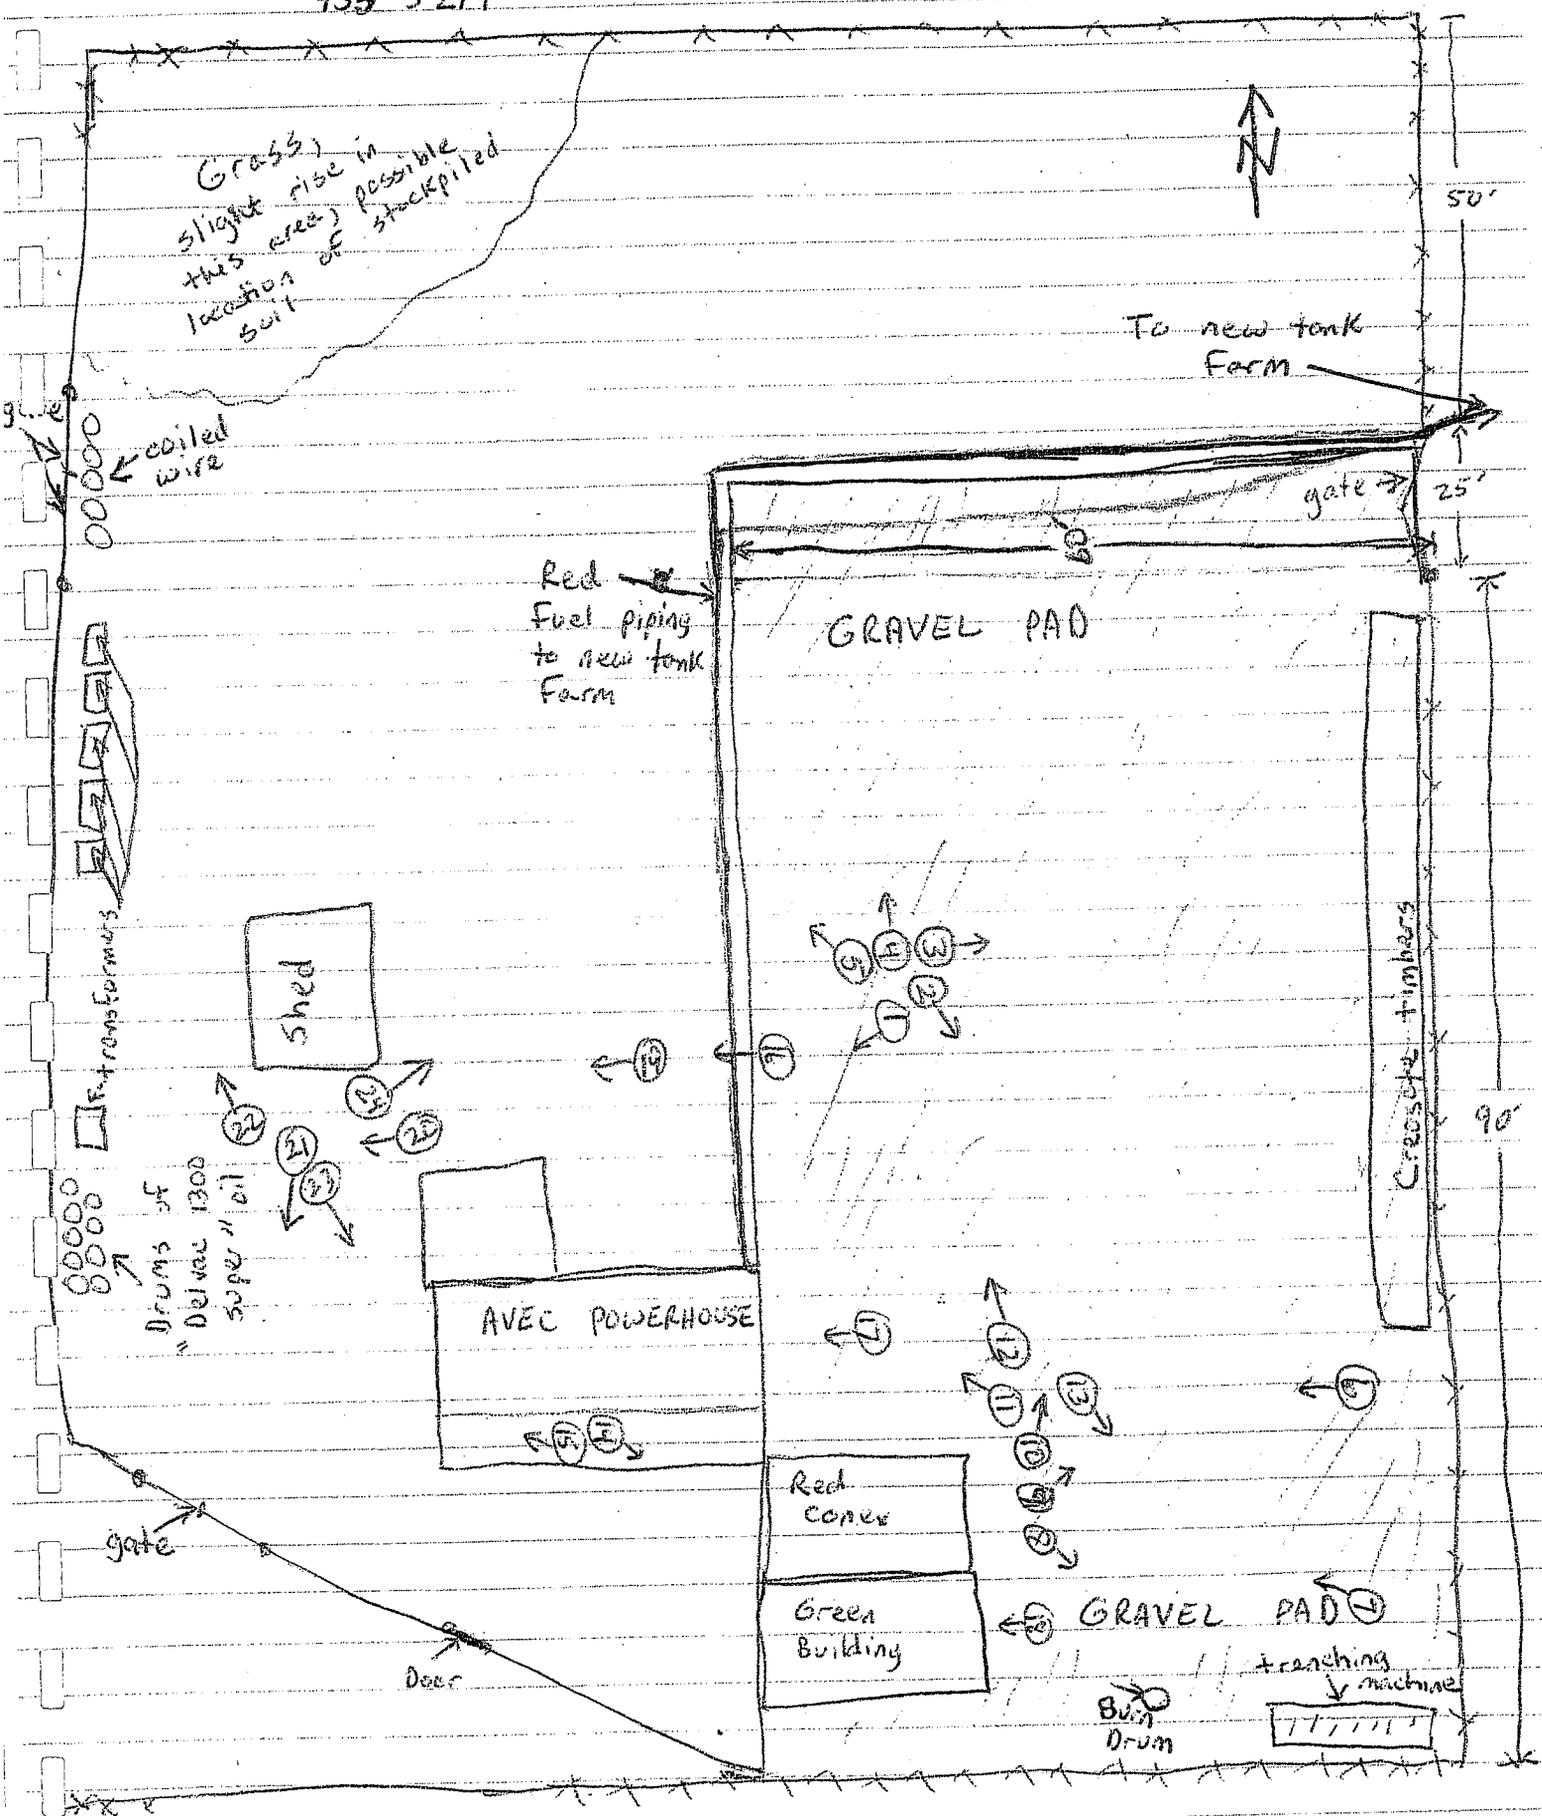
Tank Farm #5; 10/19/00, Thursday, Grayling

- According to Phil Nickoli, the original tank pad was covered with soil from the dike which had surrounded it when the tanks were moved to the new tank farm.
- Phil recalls the soil beneath the current gravel pad to be impacted with diesel fuel.
- Phil estimates approximately 12" of gravel from the dike walls currently cover the old tank pad.
- This site was not sampled.
- The gravel pad is comprised of a Rusty-Brown, slightly silty, sandy GRAVEL that was frozen at the time of our site visit.

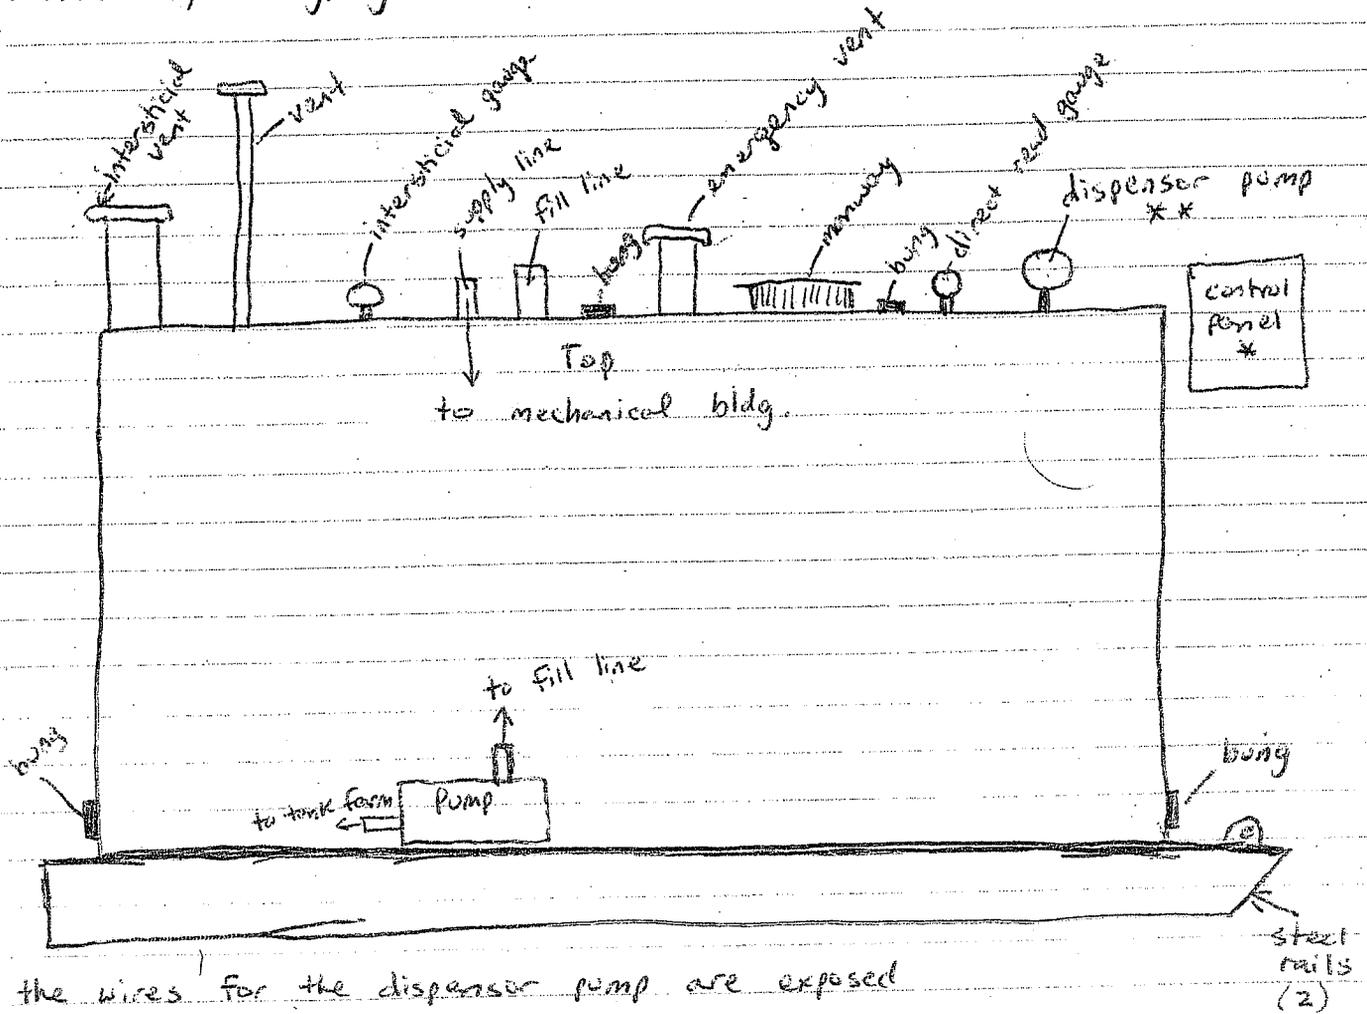
Tank Farm #7, 2000 gallon mechanical building day tank
 10/19/00, Grayling

** the wires for the dispenser pump are exposed

* the control panel is mounted on the outside of the maintenance building within the fenced area

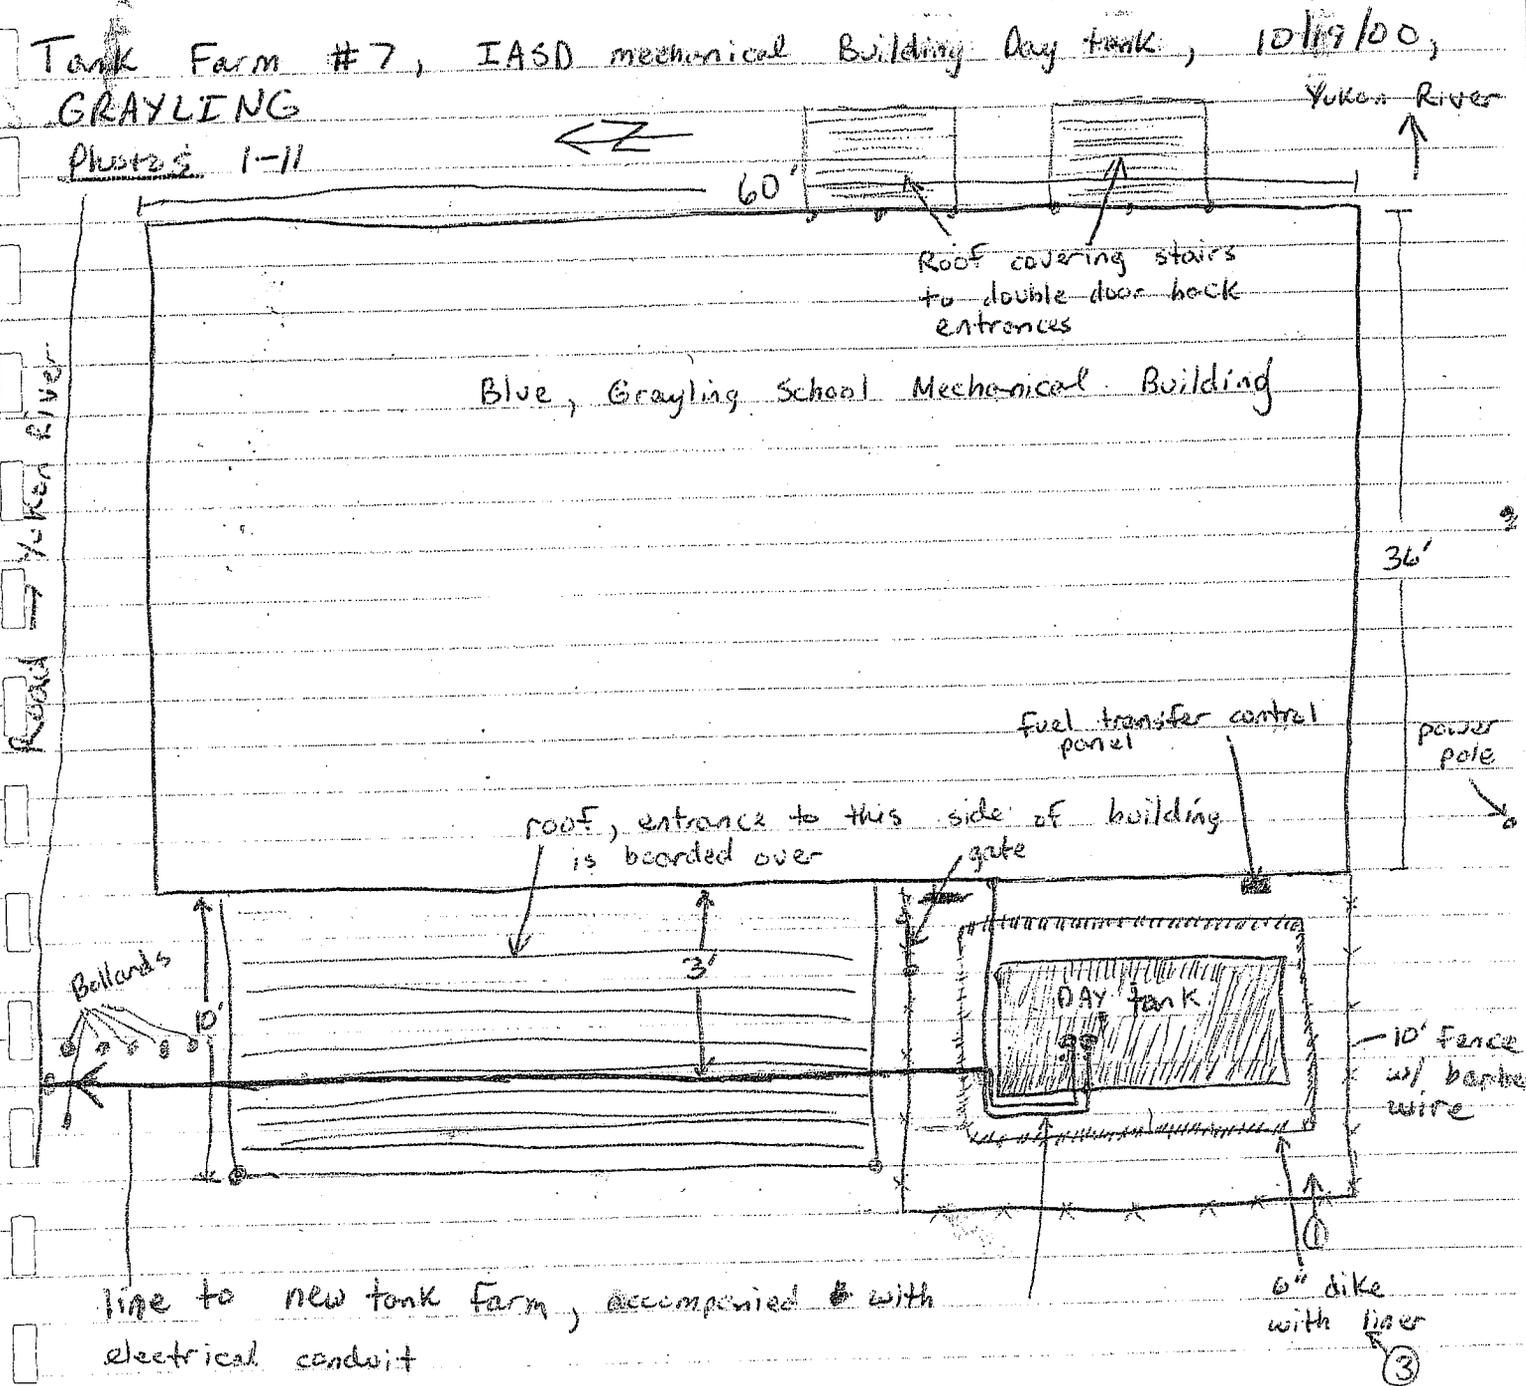
Tank Farm #7, IASD mechanical Building Day tank, 10/19/00, GRAYLING

- tank is double wall construction
- there is not any lighting to deter vandalism
- gate is not locked
- no identified emergency shut-off switch

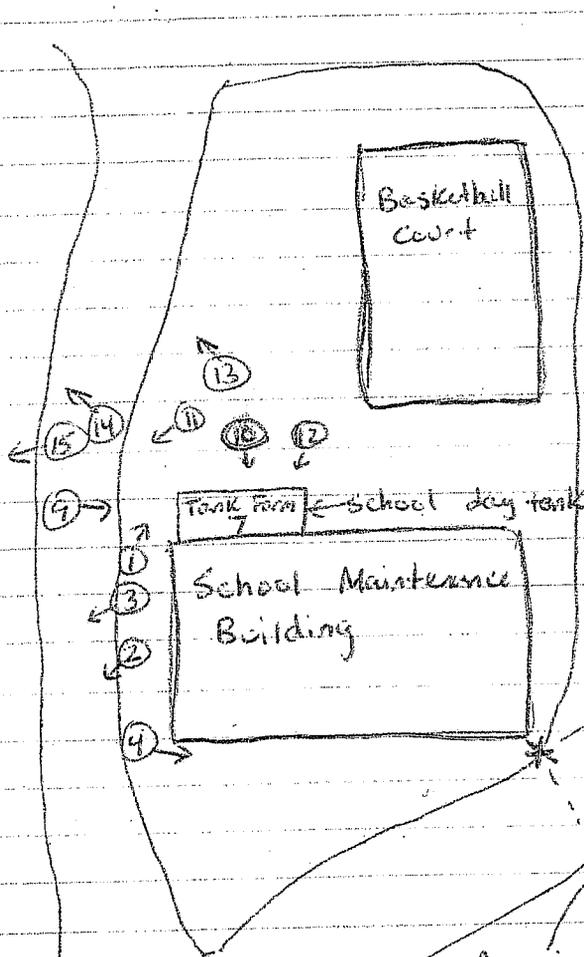
Approximate location of 3000 gallon fuel leak due to broken subsurface piping approximately 6 years ago, according to Fred Howard

Approximate location of fuel line ~~to~~ tank Farm 1
